## COVA DO VAPOR COSTA DA CAPARICA (PORTUGAL)

## 1. GENERAL DESCRIPTION OF THE AREA

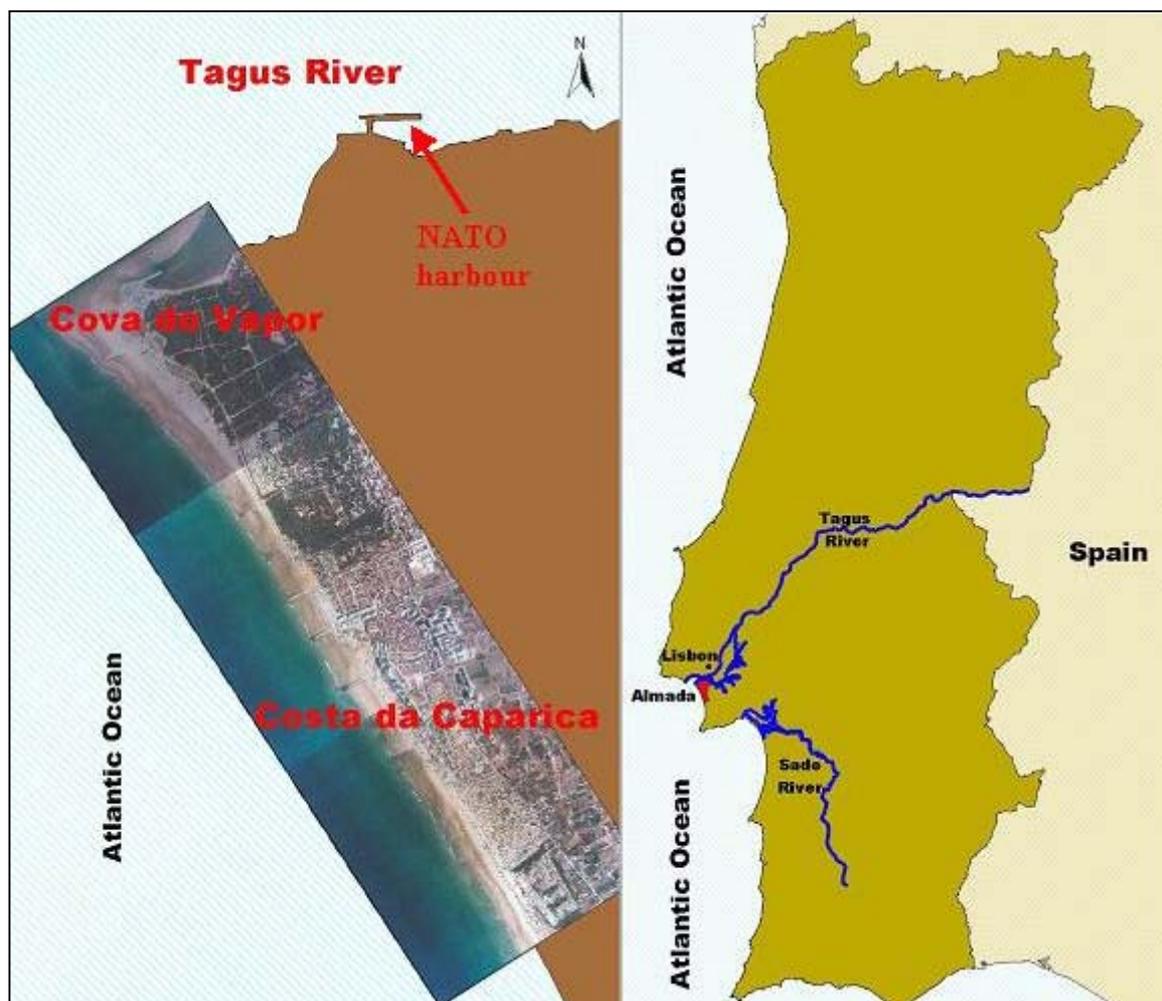
Fig. 1: Location of the groyne field maintenance with artificial sand nourishment study area.

The area is located in the South region of the Tagus river mouth and to the north of Setúbal Peninsula. This coastal zone is distinguished by a great fluvial morphodynamic influence in the river inlet area. The area of study starts in the Cova do Vapor and ends at south of Costa da Caparica village (figure 1).

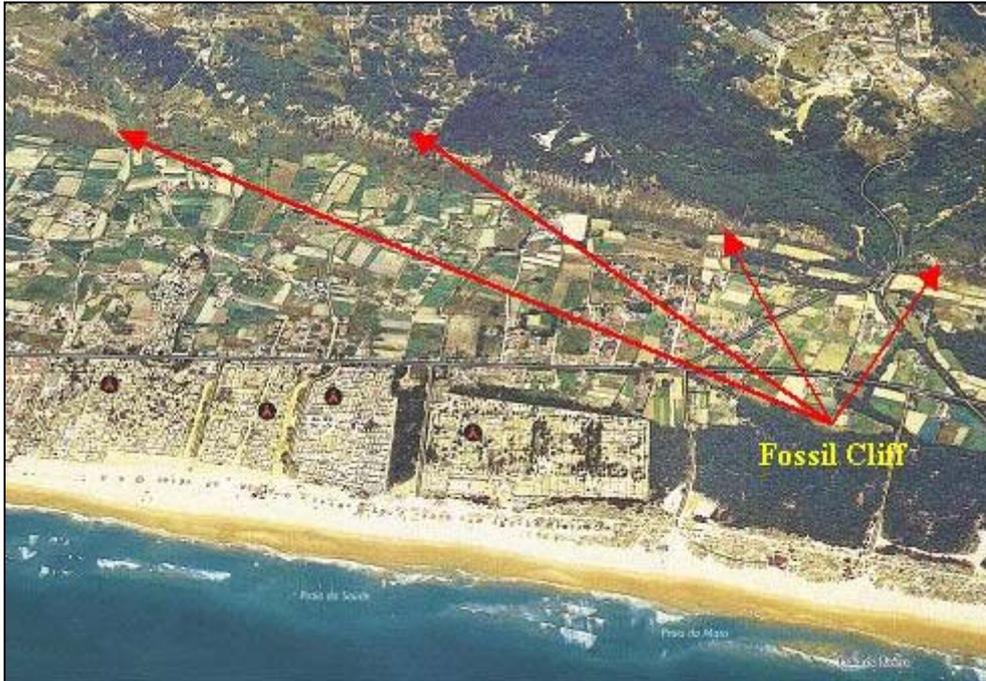
Fig. 3: Aerial view of fossil cliff (littoral aerial guide, 2<sup>sd</sup> edition, Dom Quixote).

This coastal zone is a plain coast with an arc shape that represents the most important fossil cliff in Portugal. The cliff is protected, from the sea by a considerable extension of sand. It is constituted by sub-horizontal layers of sedimentary rocks, with ages that varies between medium Miocenic period to our days.

Geologically, the area is characterized by an alluvium depositing related with the interaction effects phenomenon of waves/tides/river flow, with refraction/diffraction patterns that provoke a local alluvium transport from south to north, creating a small sand spit, in our days, near to the NATO harbour (figure 1). In the past, this sand spit had significant dimensions, projected in to the Bugio lighthouse direction (figure 5). This way, it was created an extensive alluvium on south side of Tagus river (Cova do Vapor – Espichel Cape and Bugio bar). In south of Costa da Caparica village we can find a fossil cliff that extends in the direction of Albufeira lagoon. This cliff has 70 m of maximum high, and suffered some changes through the geological times (Quaternary period) and due to erosive processes that have given those particular characteristics, this cliff become unique in Portugal. In 1984 this area was defined as a protected area (DL 168/84 of 22 of May) (figures 2, 3 and 4).

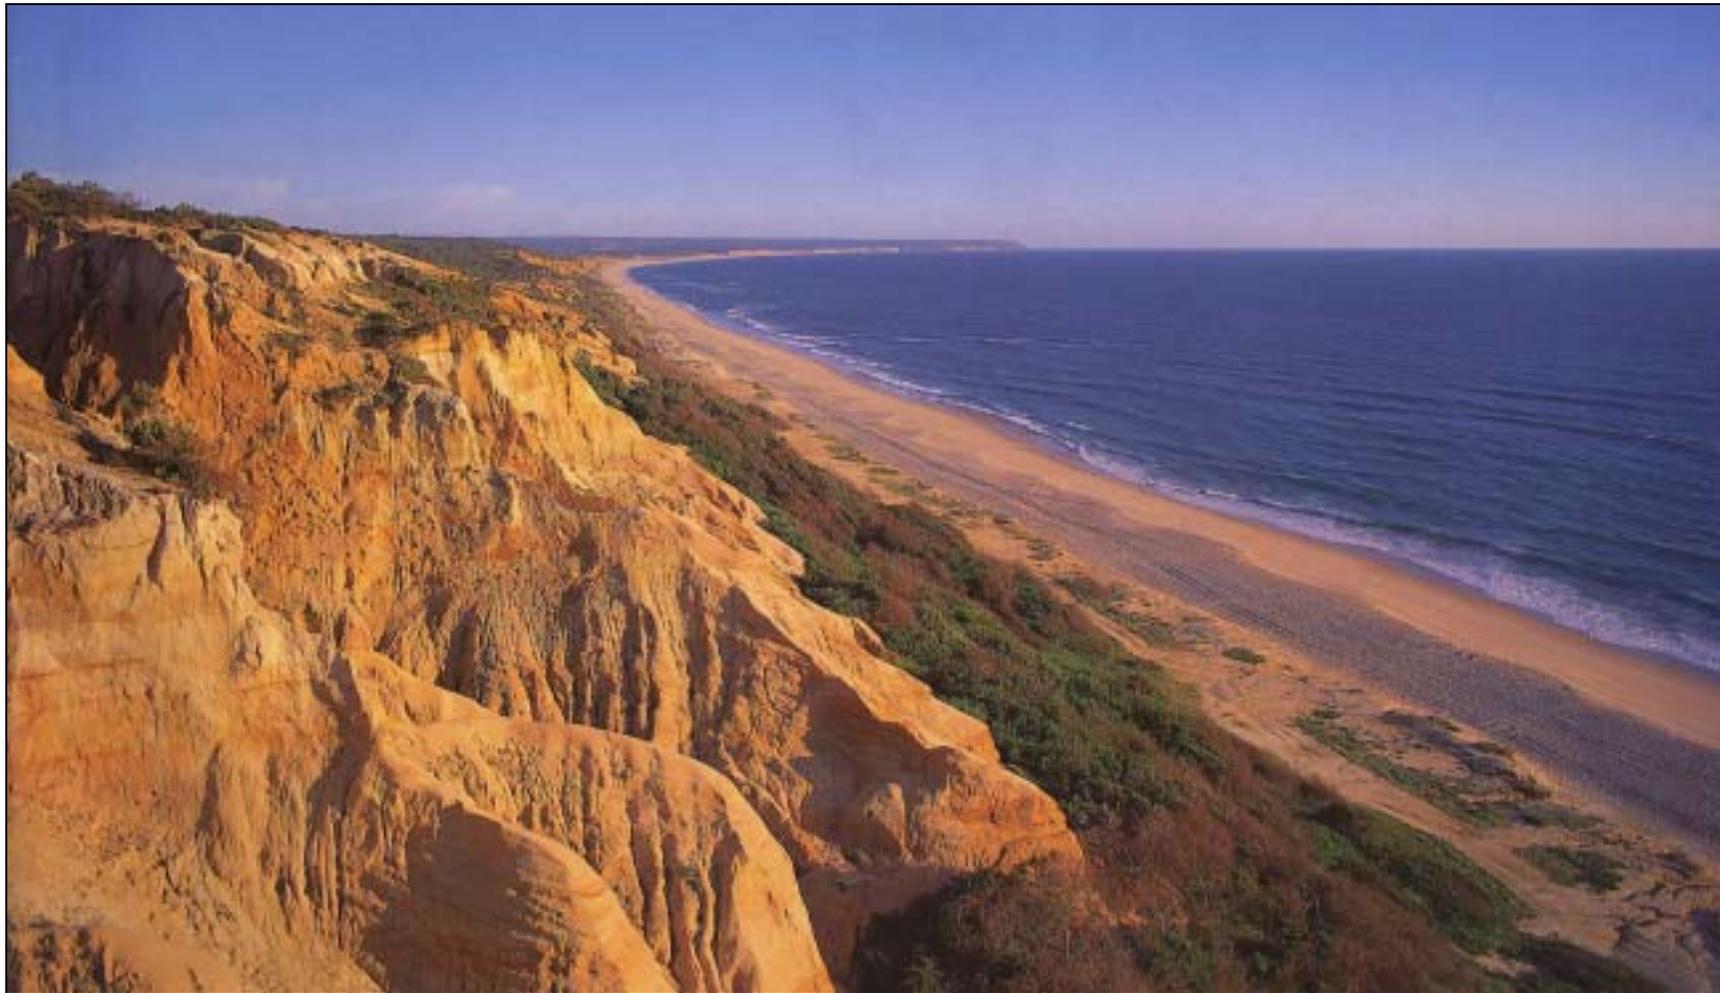
*Fig. 4: View of fossil cliff ('Paisagem Protegida da Arriba Fossil da Costa da Caparica').*

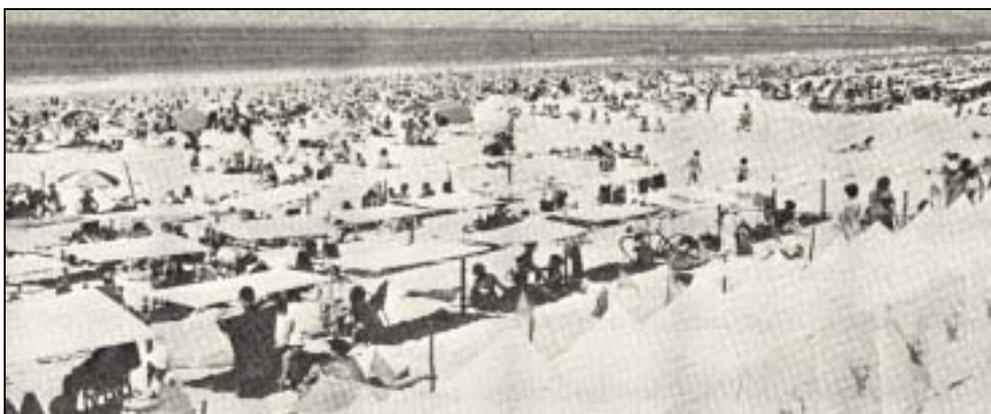
*Fig. 11: Costa da Caparica beach before starting the erosion process (Barceló, 1971).*

The coastal zone was interventioned being evident a morphologic evolution extremely dynamic. It is evident that after hundreds of years of progress to seaward direction (sand spit) and submarine accumulation (Bugio bar and Bico de Pato bar), waves and sediment dynamic have change. There are notices of erosion in Costa do Vapor since 1947, reaching the Costa da Caparica village particularly in 1958. In figure 11 and 12 is compared the situation before and starting the erosion process.

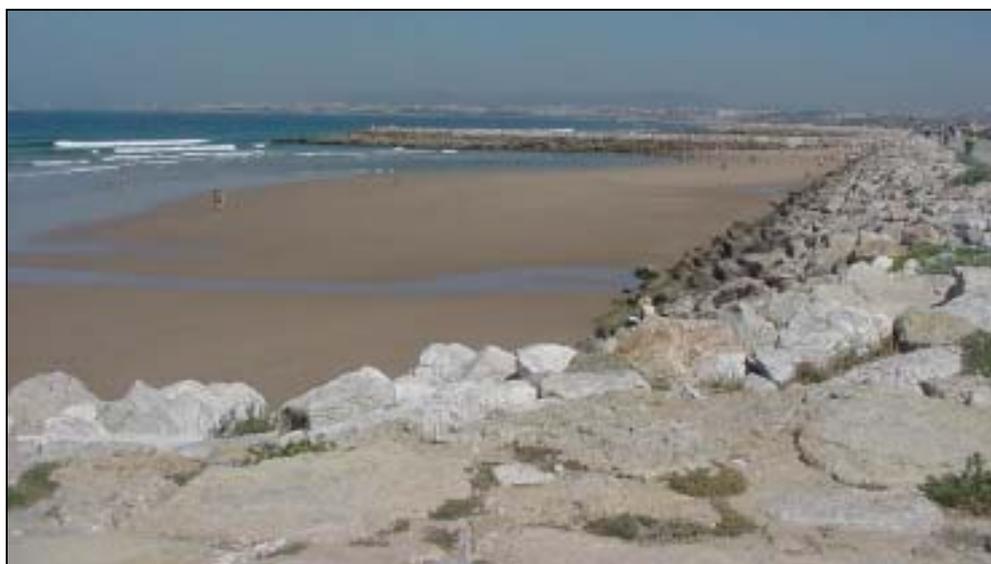
*Fig. 12: Costa da Caparica in nowadays, after starting the erosion process.*

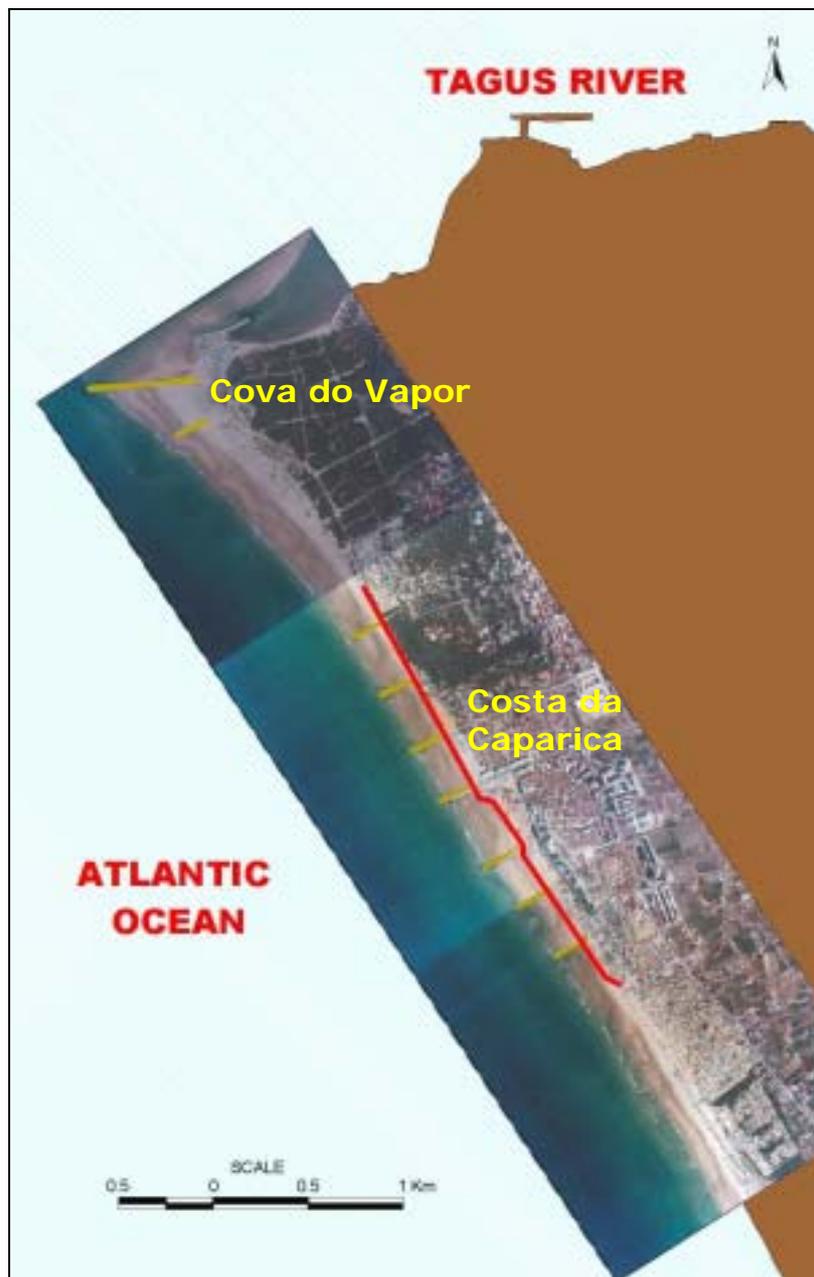
Fig. 16: Cova do Vapor and Costa da Caparica sea defences, 1996.

With progress of erosion to south, from Cova do Vapor to Costa da Caparica the situation was progressively worsening. Were fixed two defence objectives: protection of urban area against the sea actions and the recreation of beaches. This way the plan included the construction of a seawall with a length about 2500 m and the construction of a groyne field, with seven structures and the foundation on the seawall. The purpose of the groyne field was to catch and fix the small amount of sand that moves on the shore (figure 16).

The groins of this groyne field had in 1973 behaviour considered acceptable but being admitted the review of the groins length. The groins length was around 180 m and the distance between them around 330 m.
